**GROUND INVESTIGATION FOR
YENNADON QUARRY EXTENSION
FACTUAL AND INTERPRETIVE REPORT
FOR
YENNADON STONE LIMITED**

January 2011

Job No: 7397

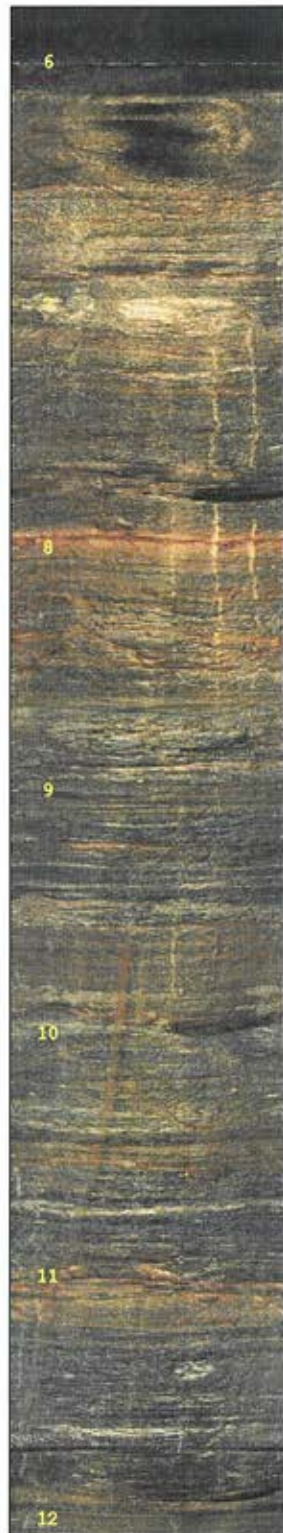
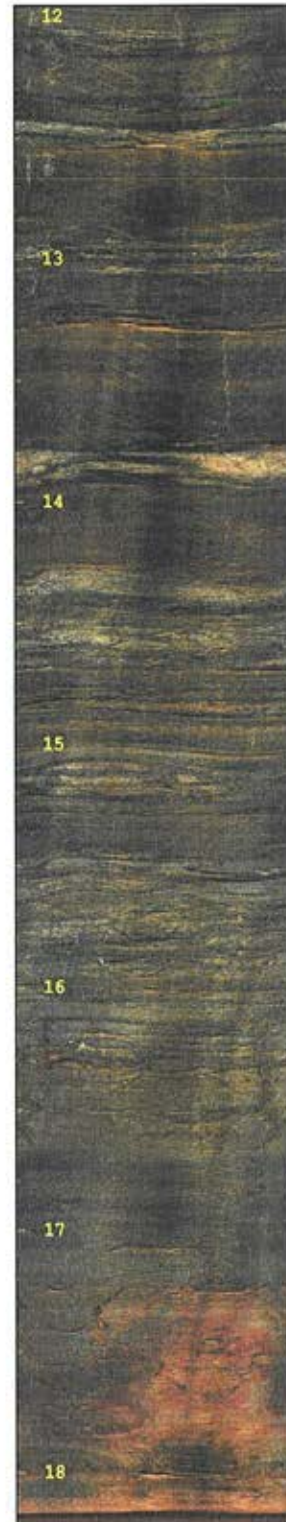
Borehole BH 1

Depth 6 -12m

Depth 12 -18m

Note borehole cased from ground level to 6.0m

BH1 experienced a minor collapse at approximately 8m bgl and was subsequently flushed with water to clean out any debris prior to being scanned by the televiewer.

The Slate encountered in BH1 was generally softer than in the other boreholes with occasional harder bands being indicated by a decrease in the drilling rate. The softer strata is likely to relate to the rock mass being more highly fractured and weathered as shown in the borehole imagery. Based on the drilling arisings, the Slate varied in colour from reddish brown to grey. BH1 was terminated at 18.2m bgl in Slate bedrock.

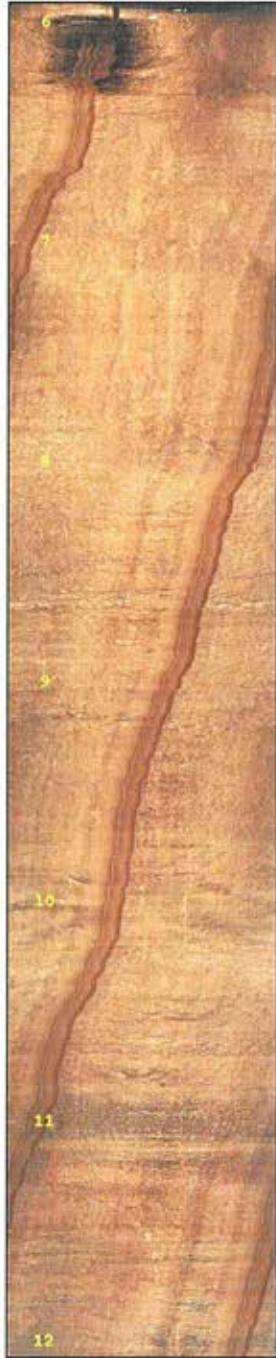
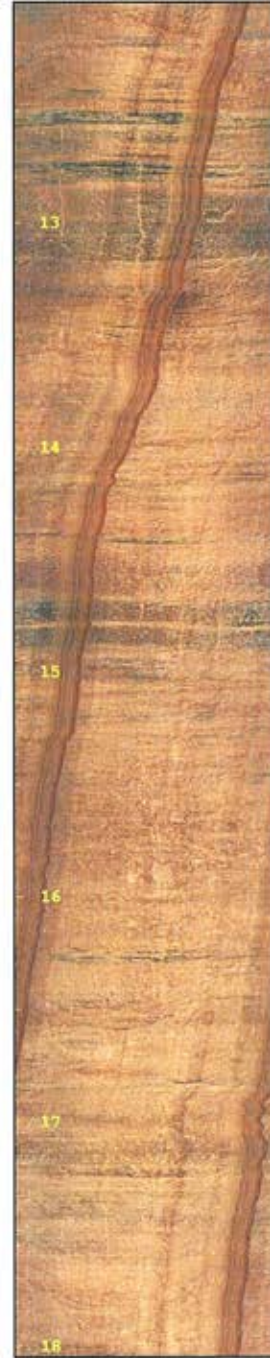
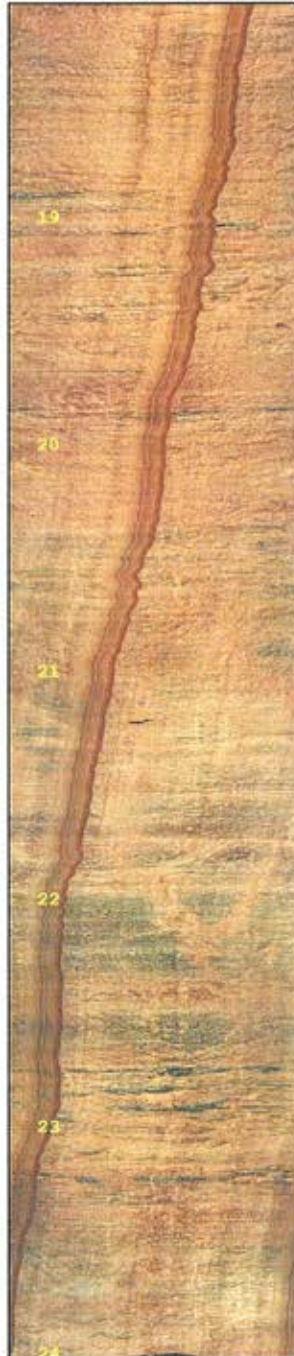
Depth 6 -12m

Depth 12 -18m

Note borehole cased from ground level to 6.0m

Borehole BH 2
Depth 18 -24m

The Slate encountered in BH2 and BH3 was consistent through its thickness, becoming slightly harder with depth indicated by a reduction in drilling rate. Borehole imagery showed the rock mass to be less fractured and tighter than that found in BH1. The colour of arisings varied slightly but generally indicated brownish red and reddish brown Slate bedrock. BH2 and BH3 were terminated in Slate bedrock at 23m and 36m bgl.

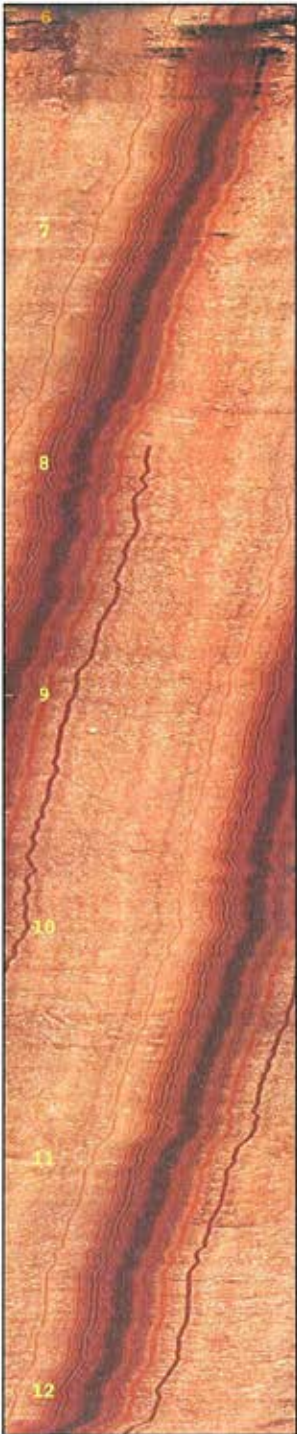
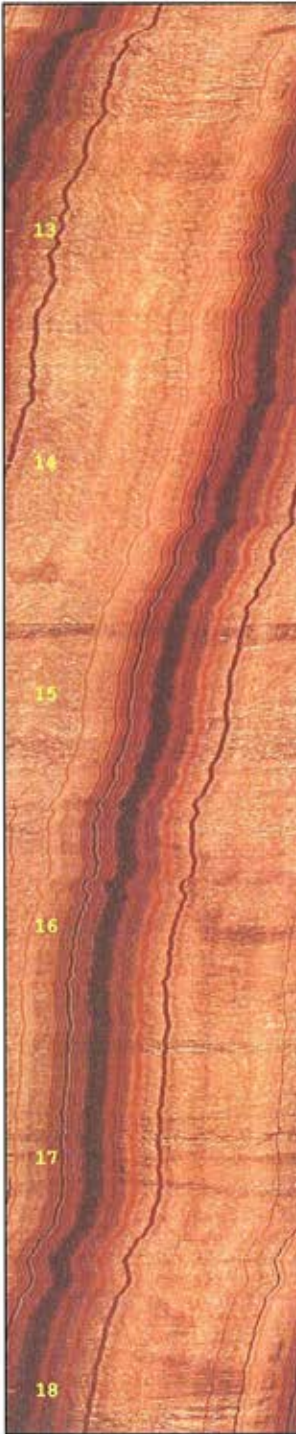
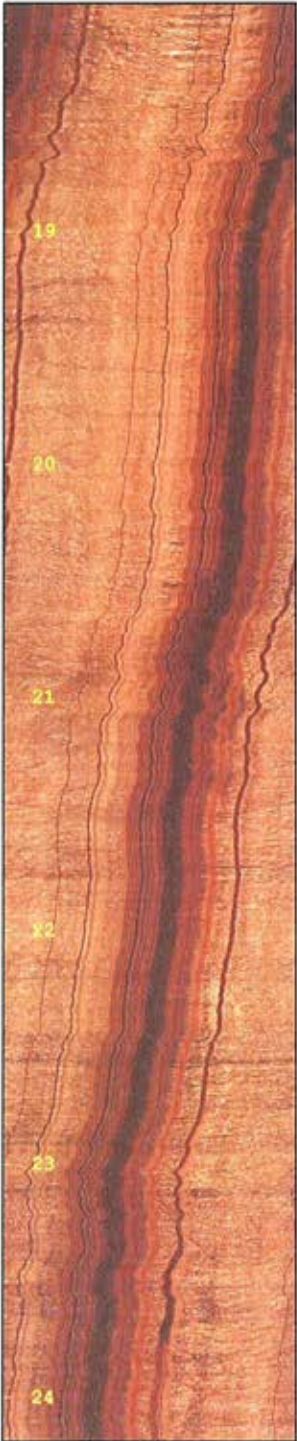
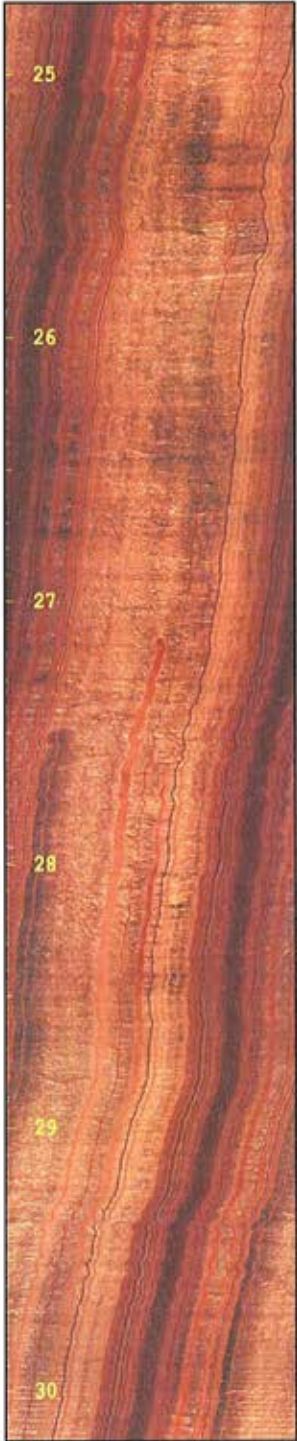
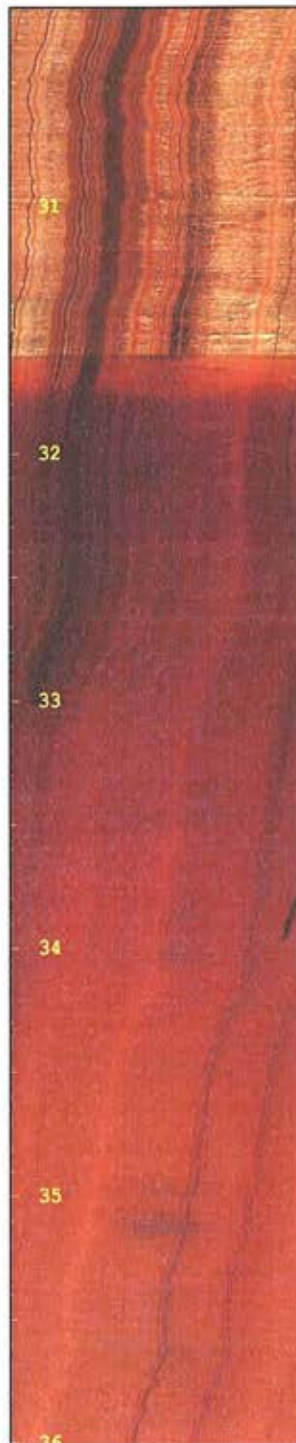
Depth 6 -12m

Depth 12 -18m

Depth 18 -24m

Depth 24 -30m

Borehole BH 3
Depth 30 -36m

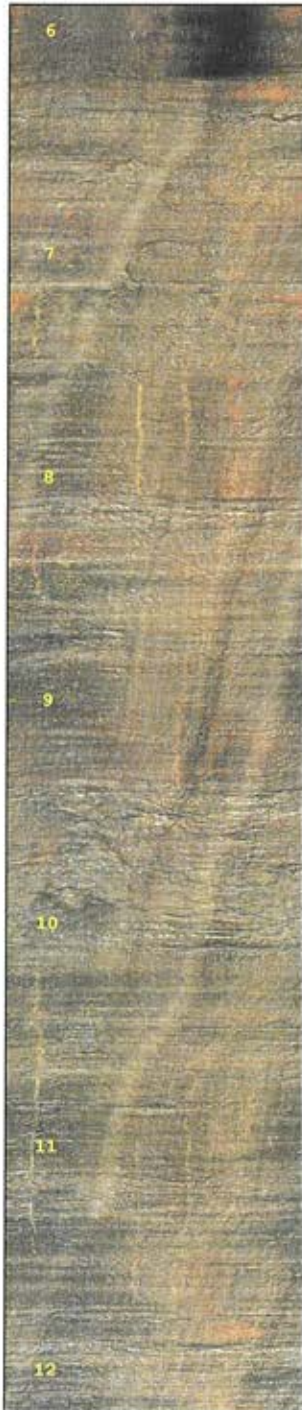
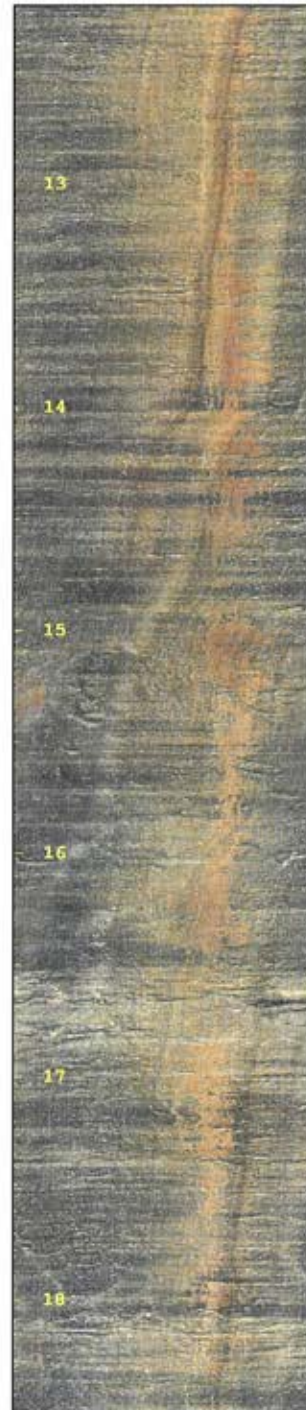
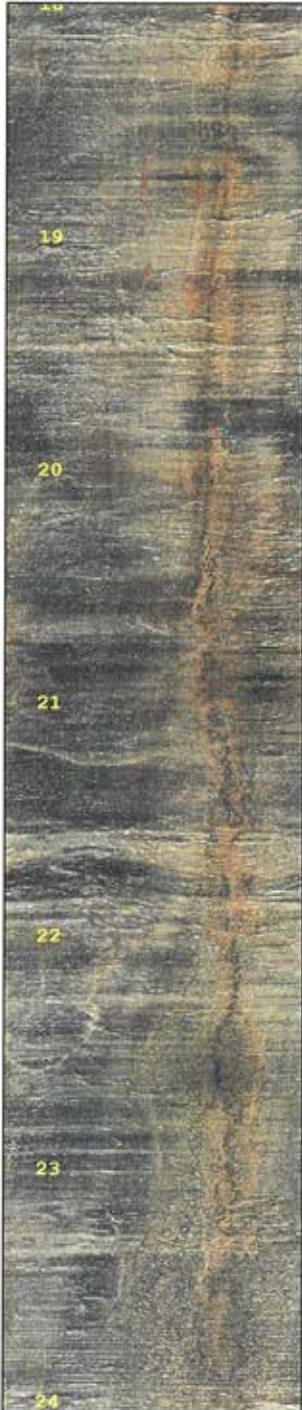
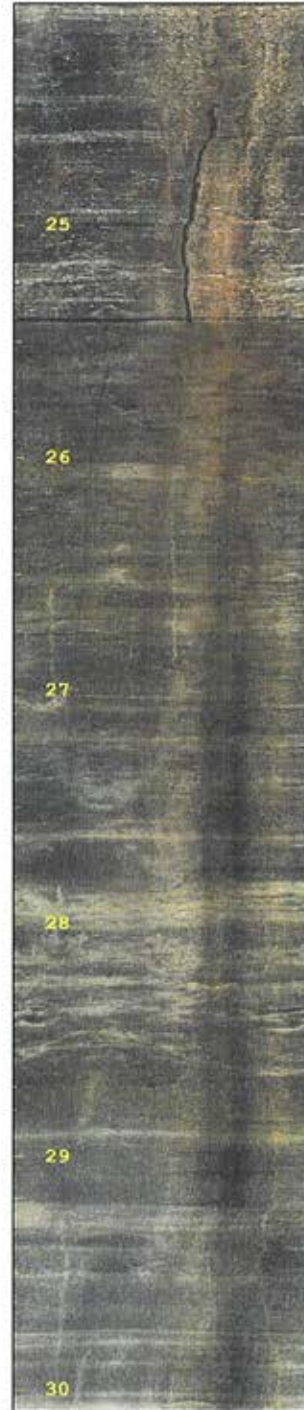
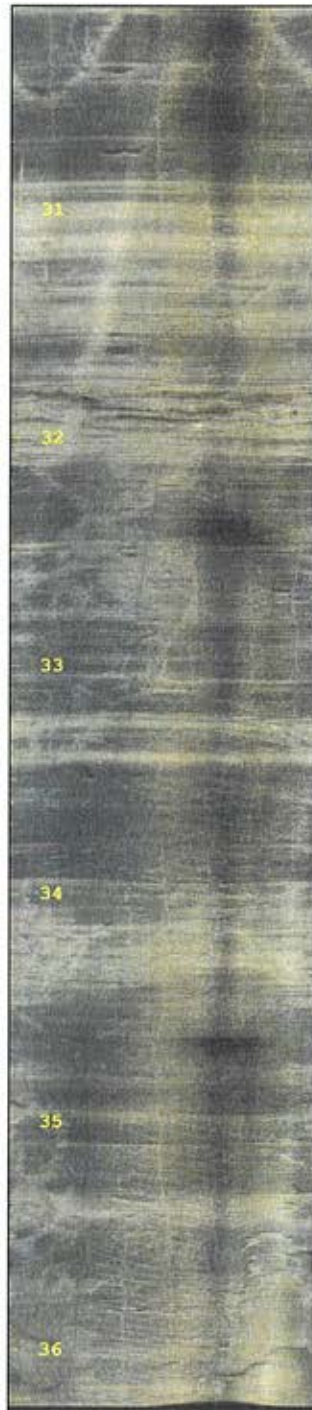
Depth 6 -12m

Depth 12 -18m

Depth 18 -24m

Depth 24 -30m

Borehole BH 4
Depth 30 -36m

The Slate encountered in BH4 to a depth of approximately 19.5m bgl was of similar hardness to that in BH2 and BH3 although slightly more fractured and of a different colour, arisings being yellowish and greyish brown. Below 19.5m bgl the rock mass became harder, indicated by a very slow drilling rate and a change in colour of arisings to grey and then bluish grey ('Janner Blue'). Borehole imagery shows a similar fracture state to a depth of approximately 28m bgl where the rock mass becomes significantly less fractured and tighter. BH4 was terminated at 36.6m bgl in Slate bedrock.
